SPECTRA
WATERMACHINES™

Case Study:
Spectra
Z-Guard
53 DeFever Yacht
Split A/C System

Performed by:
Murray Marine
Riviera Beach, Florida
(561) 842-4582
For:
Spectra Watermakers
San Rafael, CA
(415) 526-0722
Prepared By:
Gulfstream Marine Products
Largo, Florida
(727) 544-9660

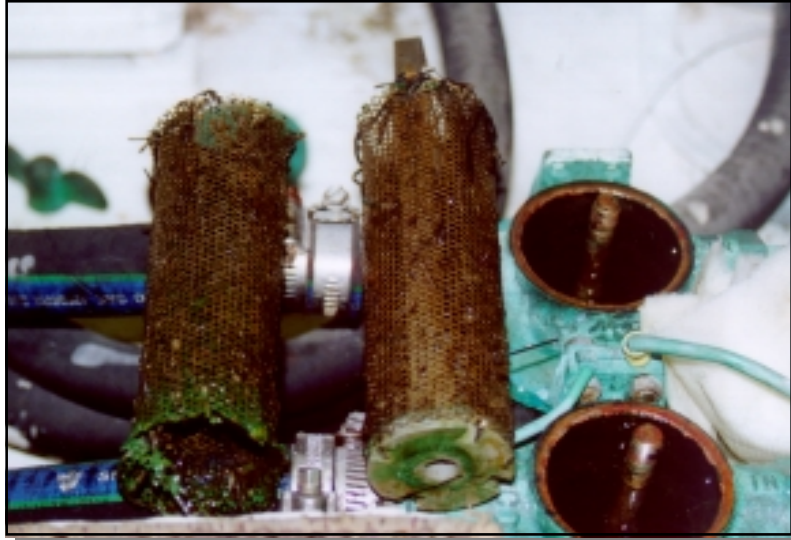
Figure “3” depicts the condition of the strainer baskets upon removal. Laid next to the receivers for the baskets, you can see that the actual condition of the strainer housing bases and connection points. The top receiver is corroded and dark from biological growth whereas the bottom receiver (the protected system) is clean and still shines after 6 months. Also note that there is less growth around the collar of the base assembly.

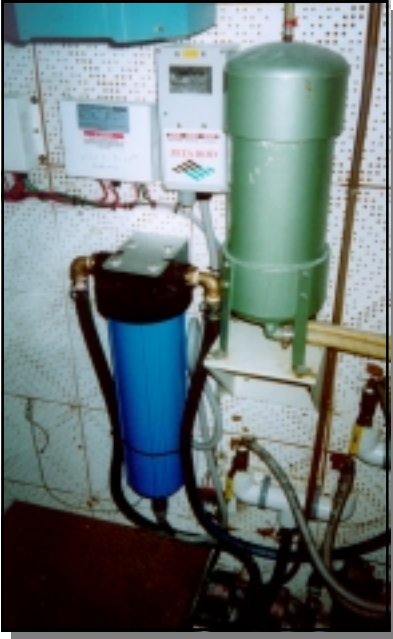
- The Spectra Z-guard needs only enough room to be able to unscrew the housing and lower it for inspection. Thus it can be mounted in any tight quarters.
- System is connected to any constant power supply using a 5 amp in line fuse (I.e. battery switch feed terminal)
- The power unit may be mounted either along side of the unit or remotely (up to the reach of the connecting harness).

*** Note Old Style Reaction Chamber shown**

Spectra Z-guard installation is very quick and simple. Here are some installation tips:

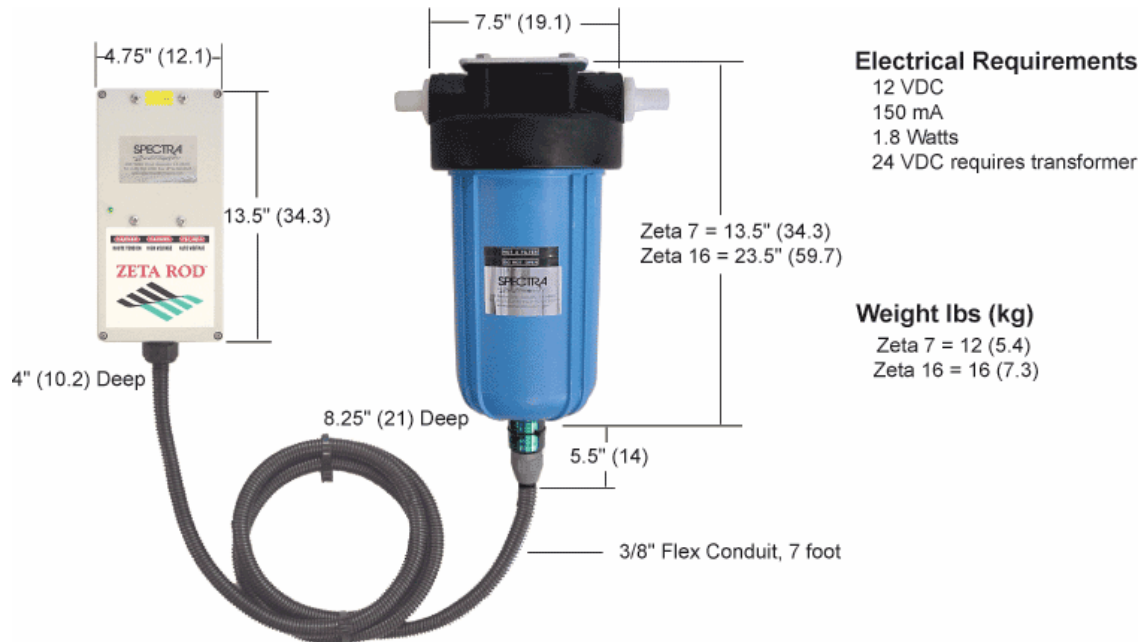
*** Note Old Style Reaction Chamber**
